Passaic Valley Sewerage Commissioners Response to Request for Information USEPA, Region 2

Service Area Drainage and
Land Use Report
for the Towns of
Harrison and Kearny,
The Borough of East Newark, and the
Cities of Newark and Paterson

Appendix C

City of Newark

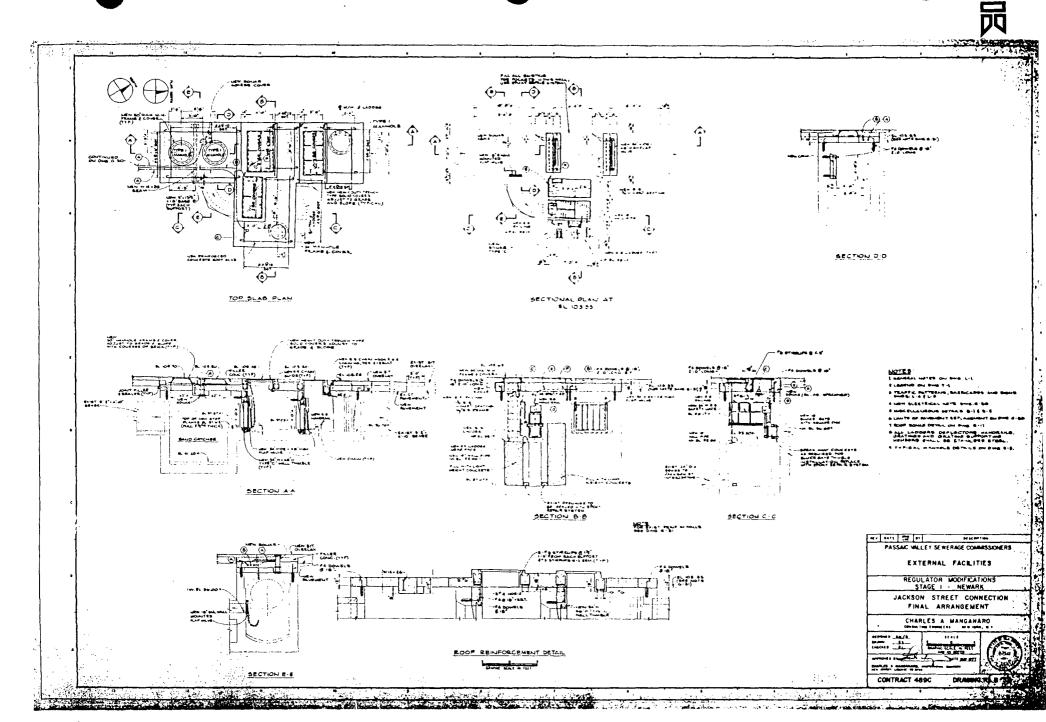
JACKSON STREET INTERCEPTOR SANDCATCHER CHAMBER--STOP LOGS 18" FLAP VALVE -18"∮ REGULATOR VALVE REGULATOR / FLOAT CHAMBER-TIDE GATE CHAMBERS TO PVSC BRANCH INTERCEPTOR — OUTFALL TO RIVER PASSAIC RIVER LEGEND PASSAIC VALLEY SEWERAGE COMMISSIONERS DRY WEATHER FLOW NEWARK JACKSON STREET, STORM FLOW / OVERFLOW SCHEMATIC (4) PLATE C

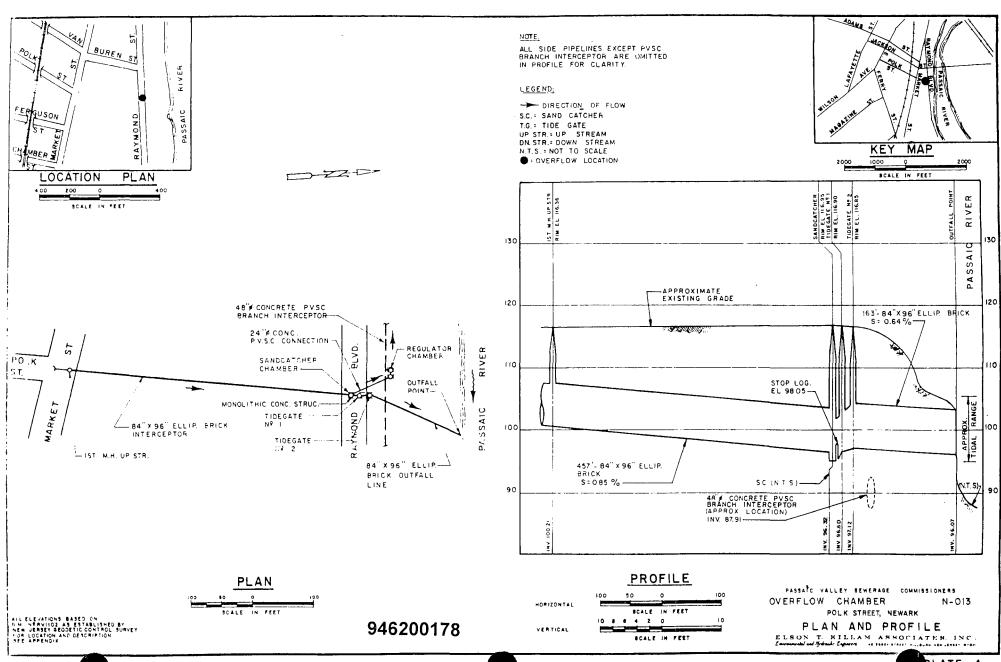
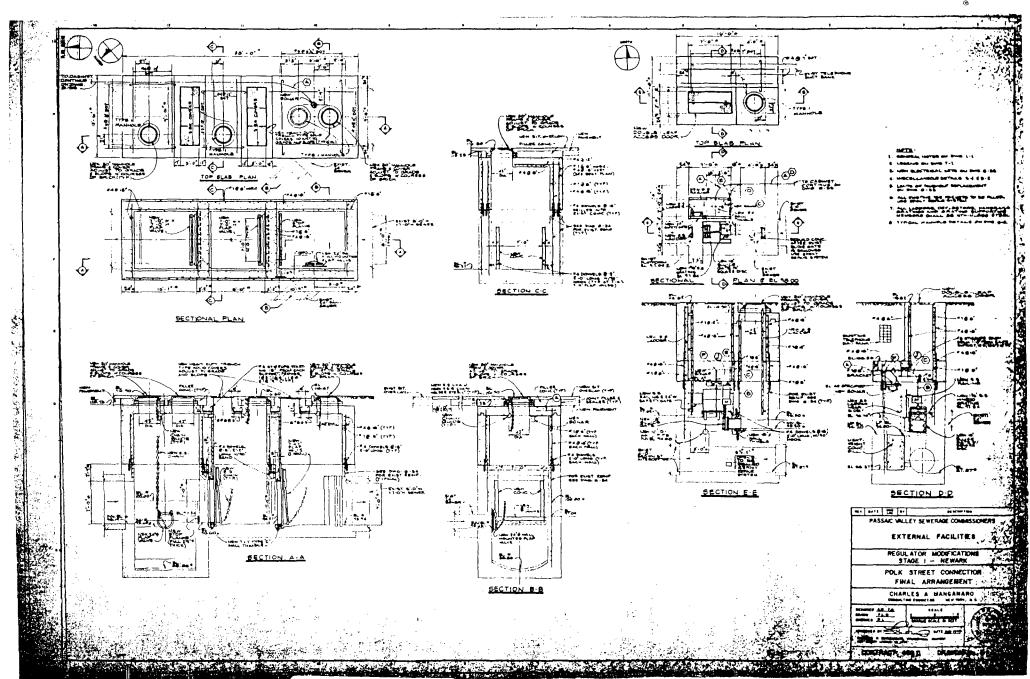
PLATE B

both tide gates leaking

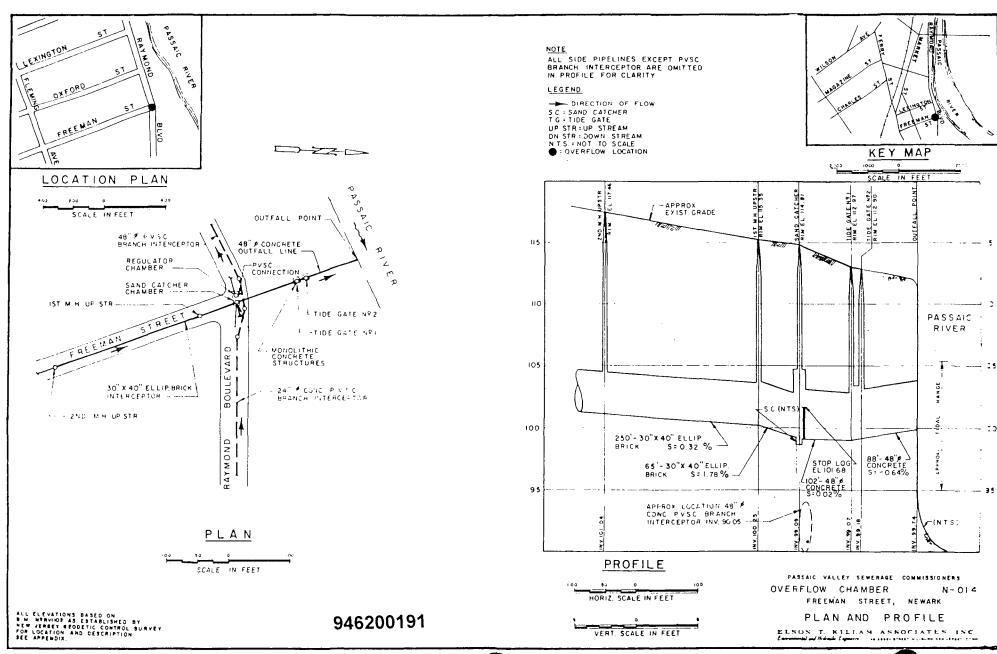
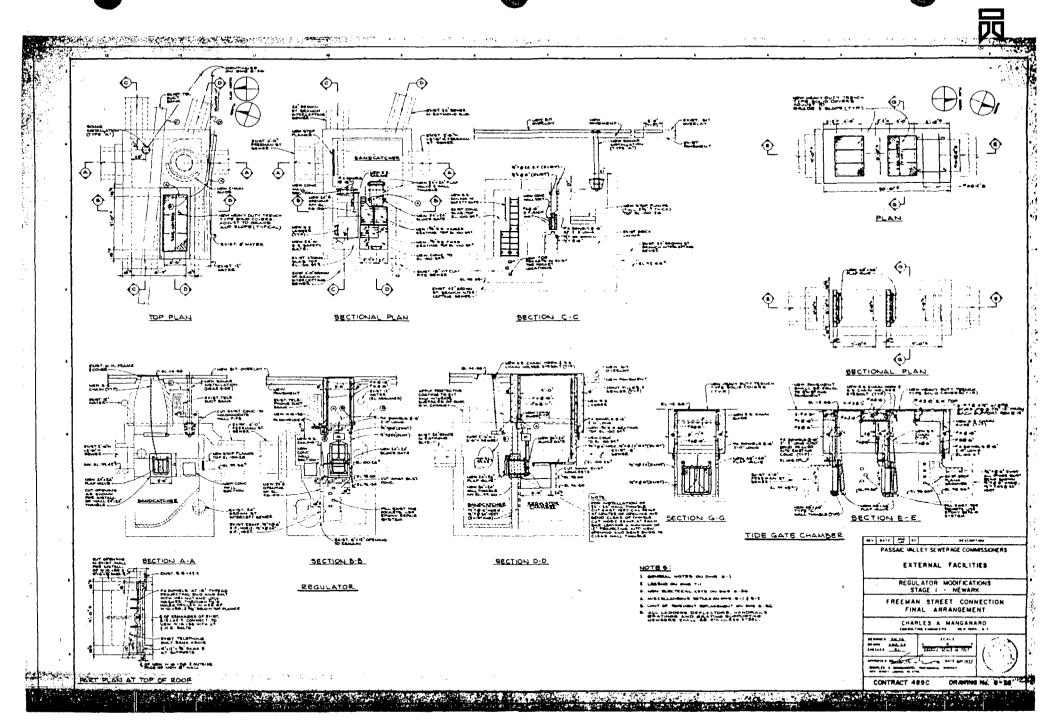
PLATE B

some tidal intrusions noted

both tide gates leaking

Some tidal intrusion was observed during the initial stages of our studies, but by adjusting the overflow weir in the chambers and repairing the tide gates, the inflow from the Passaic River has been stopped.
